Manhole Inspection Summary

Manhole # S19AA_028MH

Location Address: **2000 PAYSON ST**

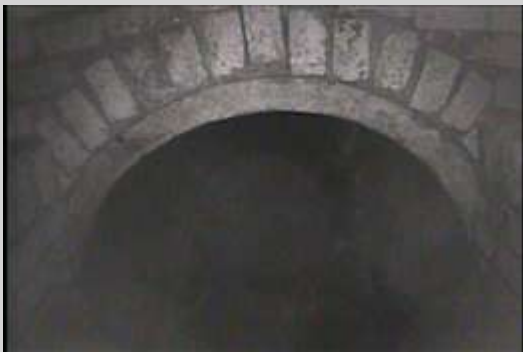
12 O'Clock Outflow

27 in. Circular Gravity Sewer
Pipe Out @ 12 O'Clock

Pipe Height: **27.6** (in.) Rod and Bar (Angled)
Pipe Material: **Clay** ☐ Pipe Lined
Invert Depth: **16.11** (ft.) Flow Characteristics: **Slow**
Deposits: ☒ None ☐ Mud ☐ Sludge ☐ Debris ☐ Grease
Silt Depth: (in.) Deposits Extent:
Infiltration: **None** Pipe Seal Cond: **Sound**

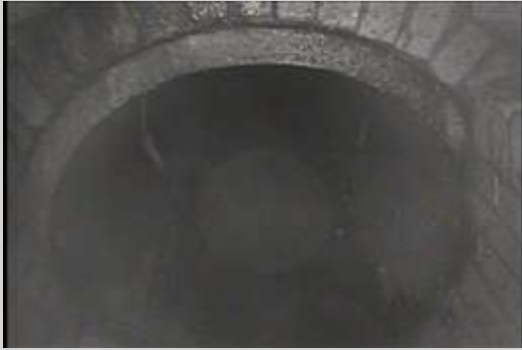
6 O'Clock Inflow

27 in. Circular Gravity Sewer

Pipe In @ 6 O'Clock

Pipe Height: **27.6** (in.) Rod and Bar (Angled)

Pipe Material: **Clay** ☐ Pipe Lined

Infiltration: **None** Pipe Seal Cond: **Sound**
